# AIP SUPPLEMENT 046/2022

## UNITED KINGDOM

## BELFAST ALDERGROVE (EGAA) - STEEL PLATES ON TAXIWAY BRAVO

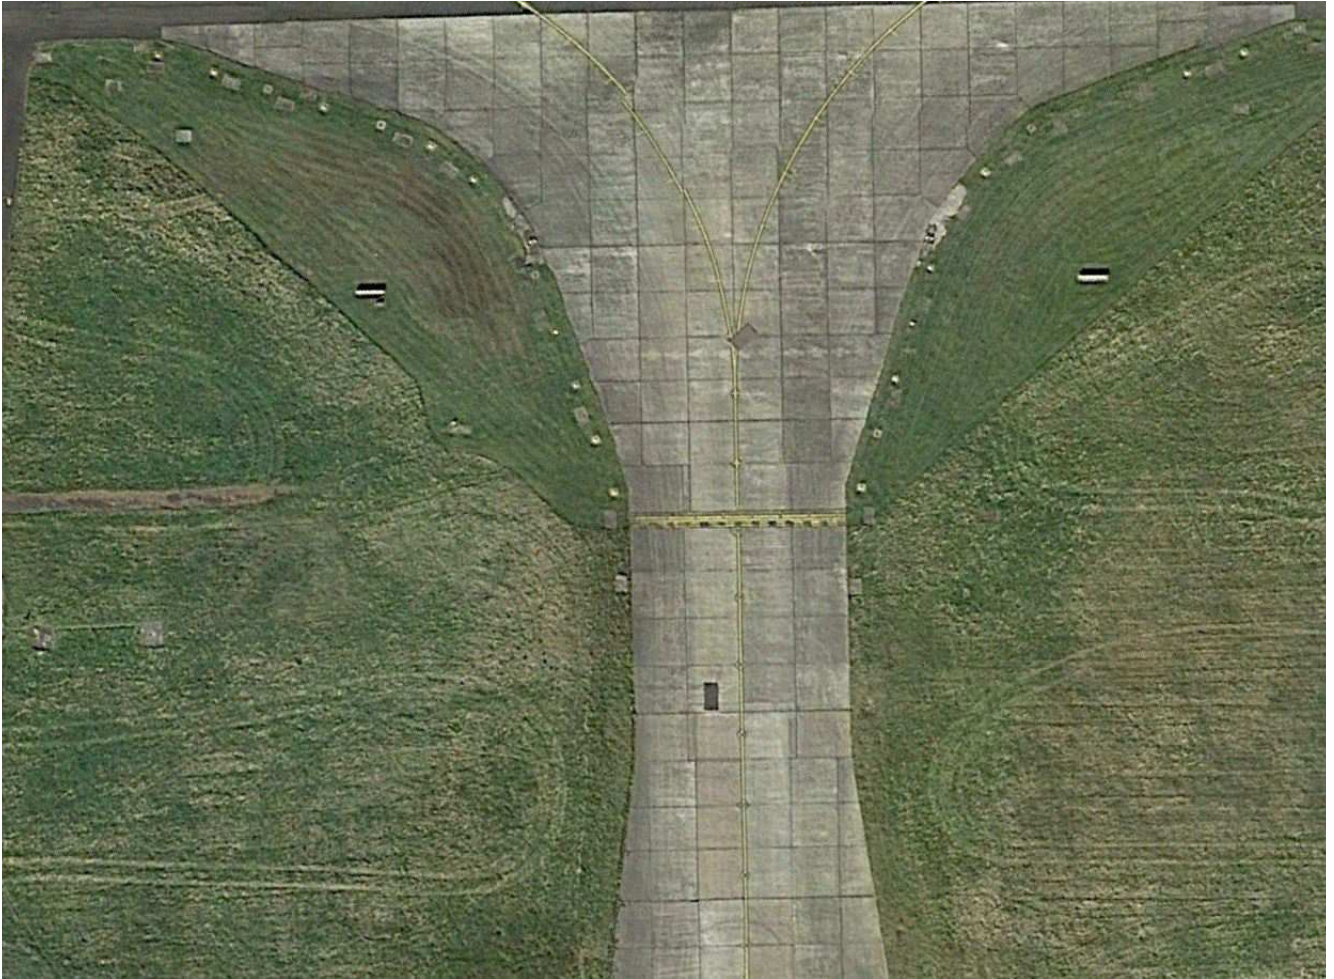
- 1 Steel Plate Covers defective surface on TWY Bravo, 20 M South of Bravo Holding Point, 3 M West of Centreline.
- 2 Steel Plate Covers defective surface on TWY Bravo, 20 M North of Bravo Holding Point, directly over TWY Centreline.
